## Difficult Slipline Necessitated Innovative Solutions

The \$8.9 million Henrico County, VA, Four-mile Creek Trunk Sewer Rehabilitation Project Contract No. 1 involved sliplining 4,000 feet of 84-inch deteriorated concrete sanitary gravity sewer pipe with 72-inch fiberglass pipe.

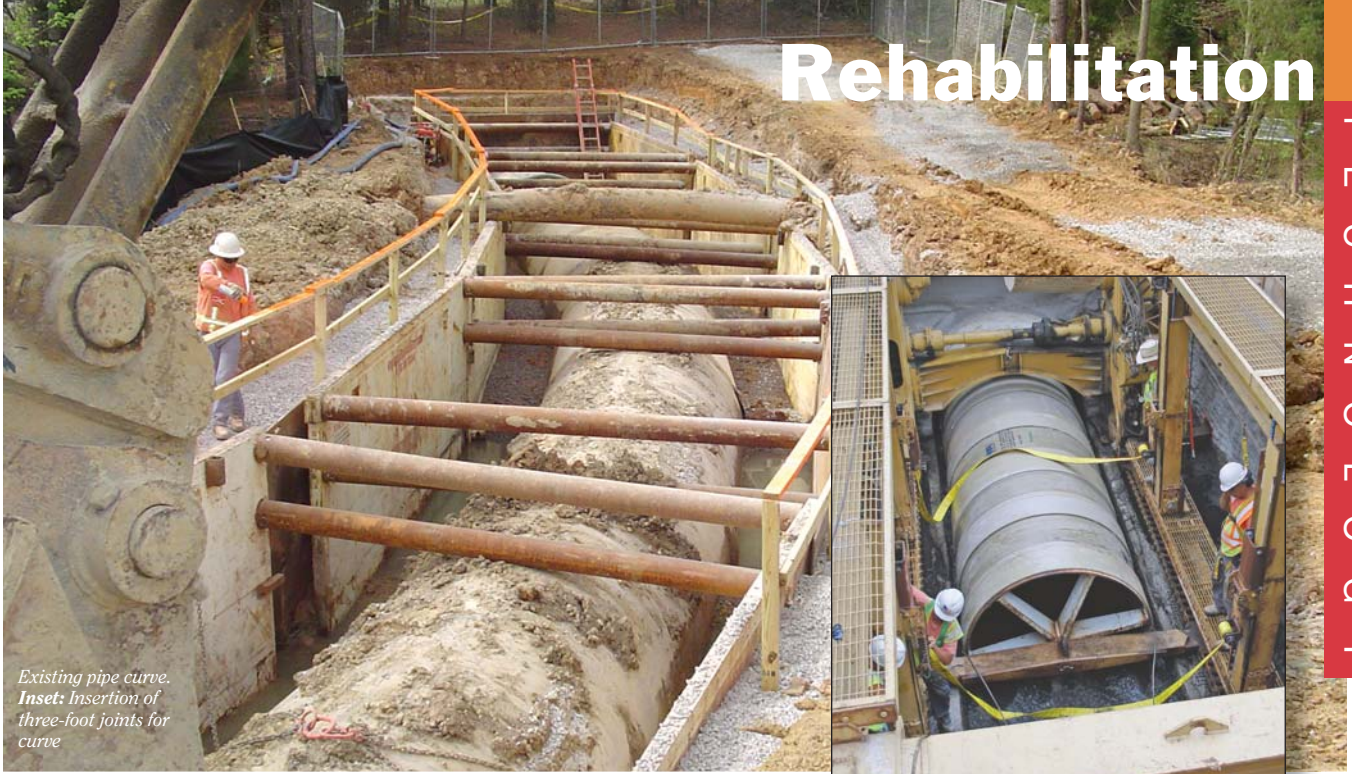
*Existing pipe curve. Inset: Insertion of three-foot joints for curve*

FPI recommended using three-foot long pipe sections with gasketed spigots at both ends and a double bell floating coupling. Also, a coupling stop ring was bonded to each pipe to prevent the coupling from moving during the slipline push operation. This configuration would allow three times the standard joint deflection. Although the FPI standard low profile slipline pipe has a single O-ring on the spigot, it was decided to put 2 grooves and O-rings on each spigot to ensure a tight joint and account for the numerous unknowns about the condition and alignment of the existing pipe to be lined.
